# Climax Springs

# Premium Spring Water

## Chapter 3.0 Site Reconnaissance Summaries

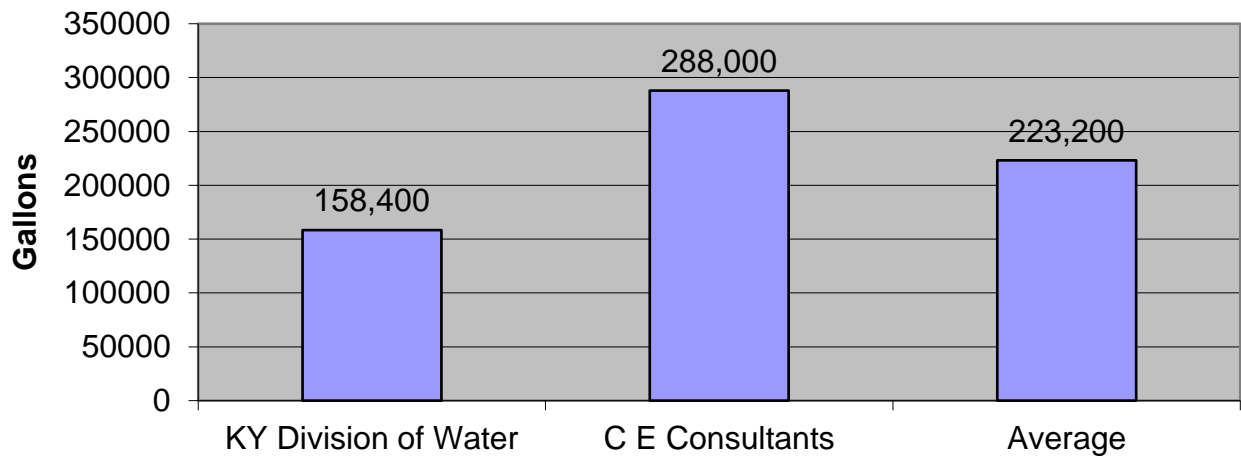
**Gallons of Water per Day**

Climax Spring has a tremendous volume of water that emits from its source. Estimates run from 158,000 gallons per day to 288,000 gallons per day flow.

**Estimates by Companies**

- **Volume:** *Climax Spring* has a tremendous volume of water that emits from its source. Estimates run from 158,000 gallons per day to 288,000 gallons per day flow.

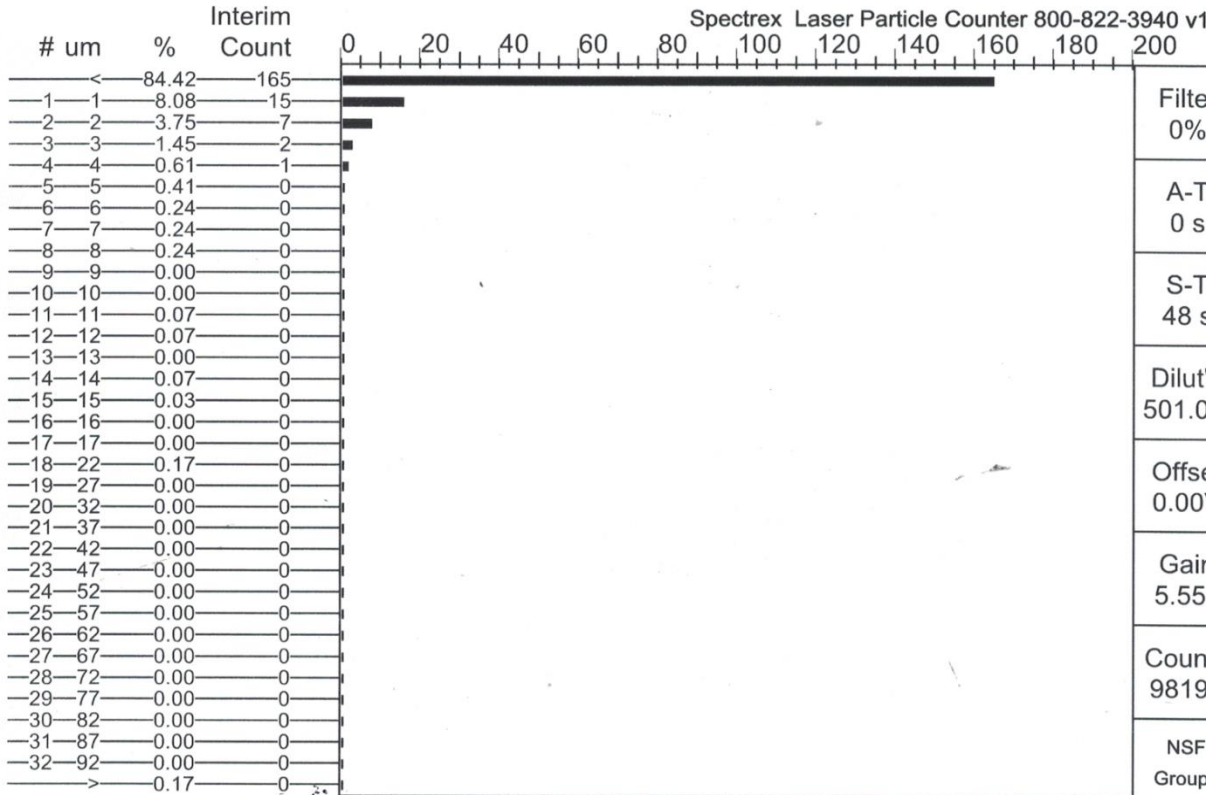
**PARTICLE ANALYSIS:** This report shows the size of the particles that is in the raw spring water. As you can see 84% of the particles are under 1 micron in size. This sample from the spring was taken when the Turbidity measured 2.81 NTU.

Bin	Size	Total counts /cc	Counts percent	Surface area percent	Volume percent	Mass/bin ppm
---	< 1	82,892.30	84.42%	0.00%	0.00%	0.0000
1	1-5	13,643.87	13.89%	21.67%	6.59%	0.0466
2	5-15	1,294.67	1.32%	36.14%	28.82%	0.2039
3	15-30	199.18	0.20%	42.20%	64.59%	0.4571
4	30-50	0.00	0.00%	0.00%	0.00%	0.0000
	50-100	0.00	0.00%	0.00%	0.00%	0.0000

Total counts: 98,196.00/cc  
 Total suspended solids: 0.71ppm (mg/liter)  
 Dilution factor: 501.00:1  
 Spec. gravity: 1.00  
 Mean size: 2.34um  
 Standard dev: 2.87um

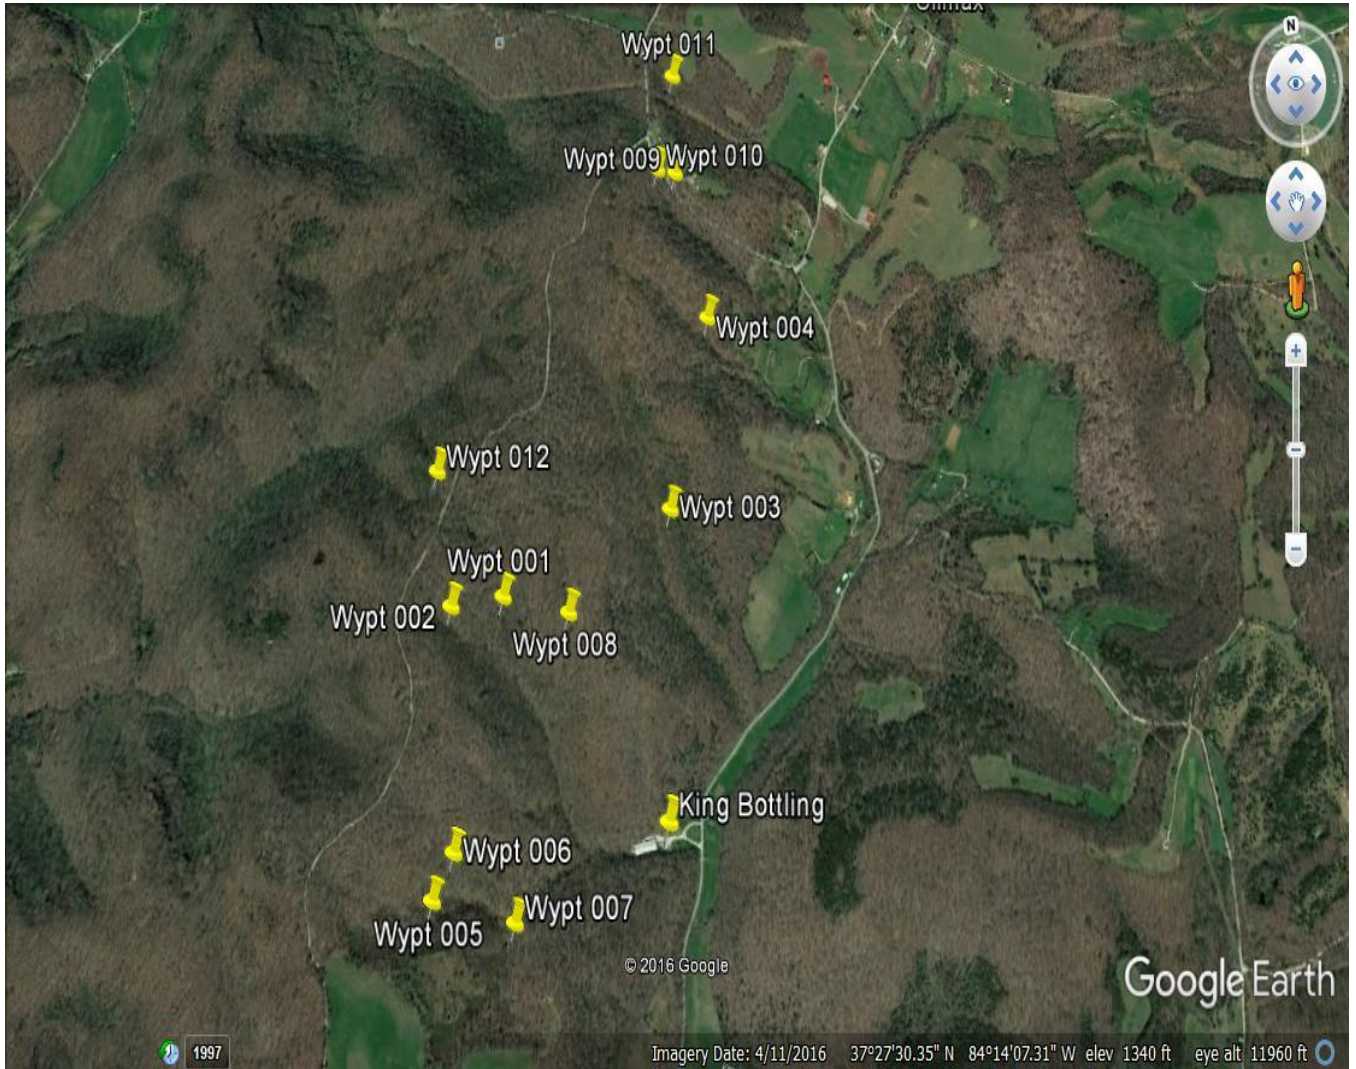
**THE 12 SPRINGS THAT FLOWS TO THE WATERFALL THAT MAKES UP THE SOURCE FOR CLIMAX SPRINGS:**

This image below shows the location of the 12 springs that feeds the waterfall. The springs start over the hill and around 1400 ft elevation the water disappears into the stream bed. The water then falls into a karst area under the mountain and all of the water discharges at the waterfall. All of the springs are in the Daniel Boone National Forest with the exception of Wypt 011.
